A Red Light Running (RLR) Photo Enforcement System was installed at the intersection of Illinois Avenue at Plum Grove Road on May 1, 2008 (northbound), after finding limited success with other attempted measures to promote safer driving and improve compliance with traffic laws. As a condition of use, both Illinois law and the Illinois Department of Transportation require periodic statistical analyses/evaluations be conducted.

Illinois Avenue at Plum Grove Road Palatine, IL

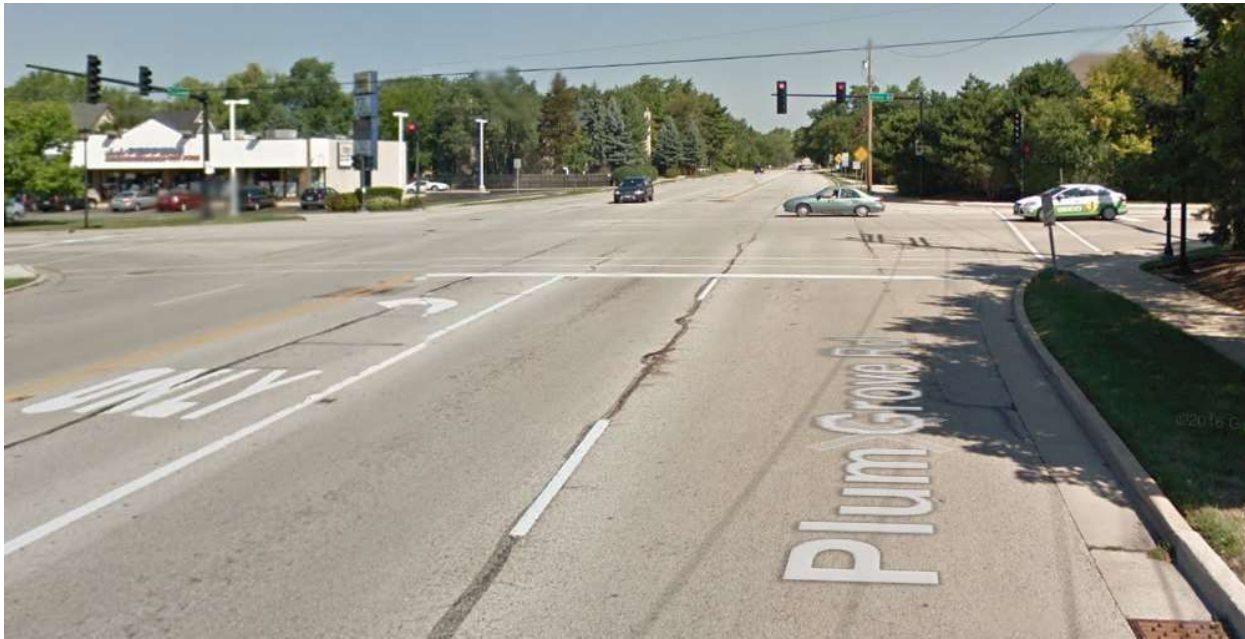
Illinois Avenue at Plum Grove Road, Northbound Approach

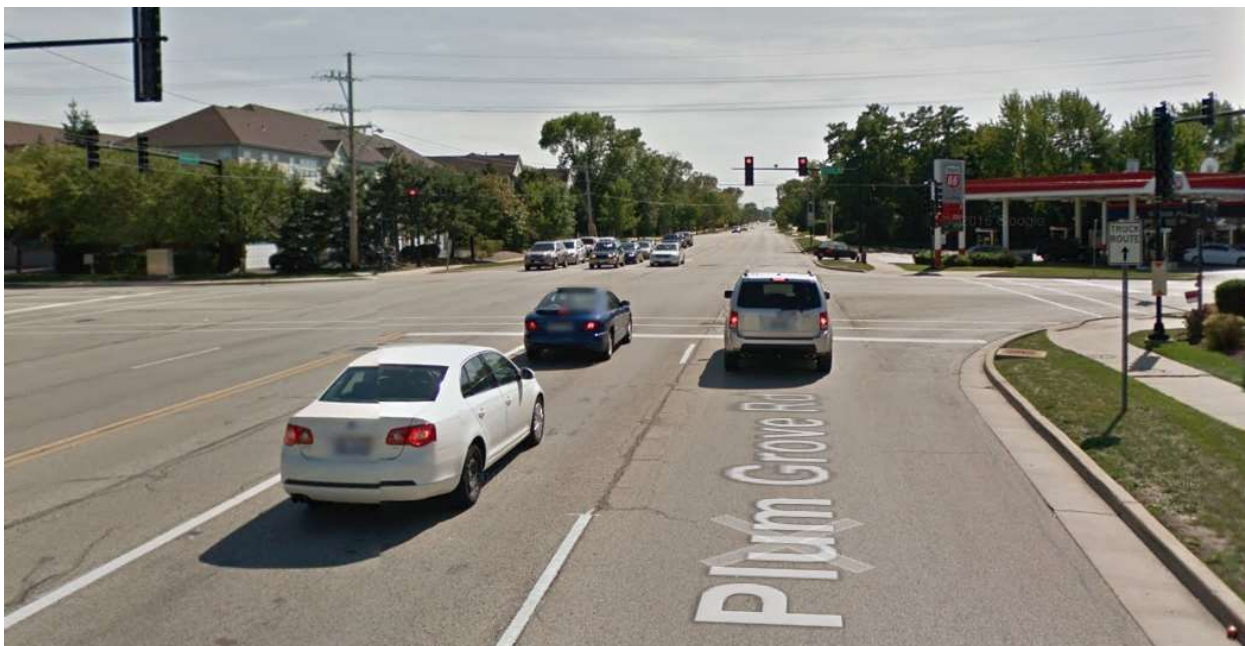
Illinois Avenue at Plum Grove Road, Southbound Approach

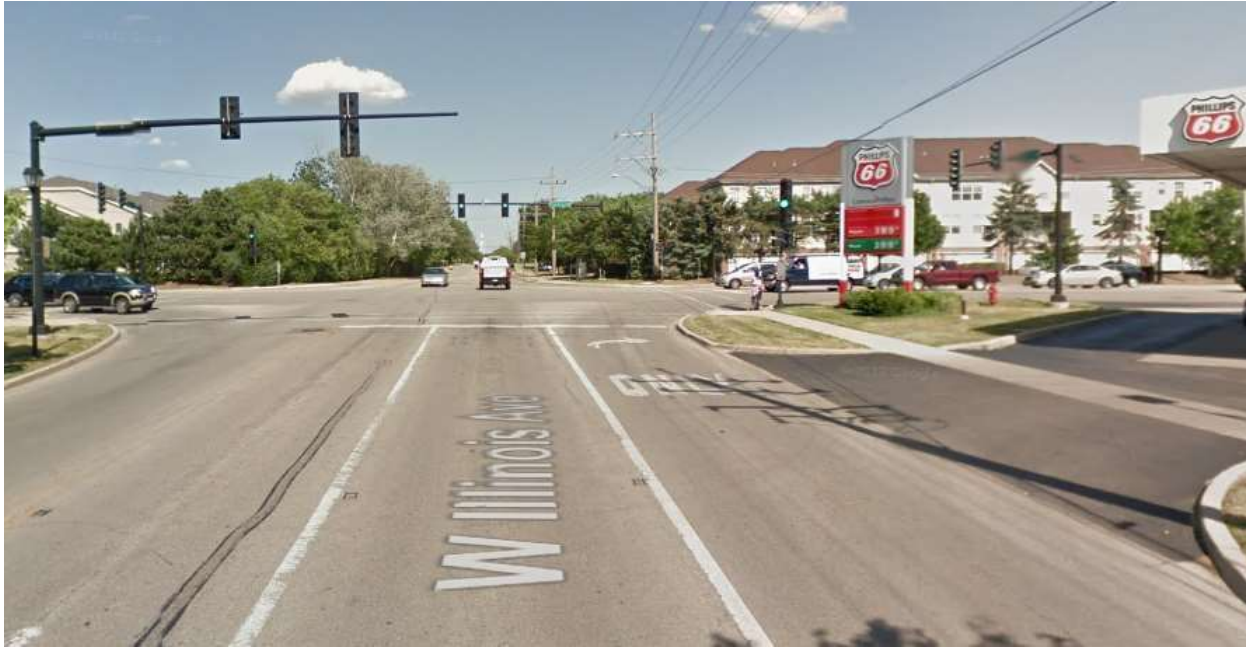
Illinois Avenue at Plum Grove Road, Eastbound Approach

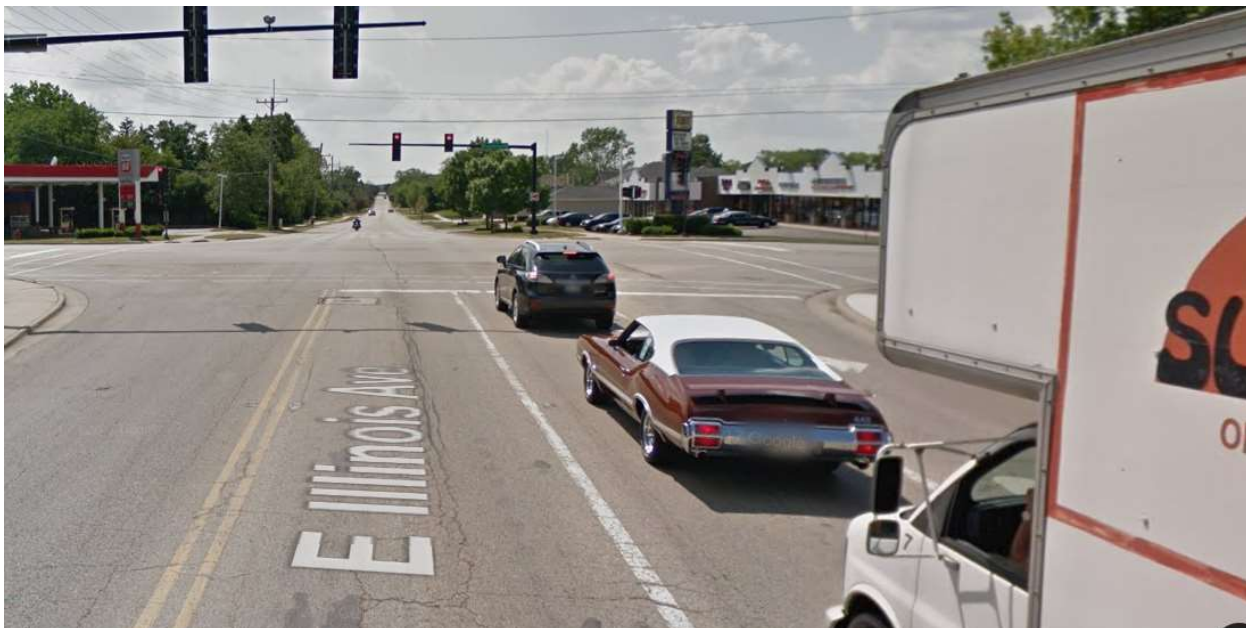
Illinois Avenue at Plum Grove Road, Westbound Approach
