The following statistical analysis and evaluation was performed through 2018.

US Rte. 14 (Northwest Hwy) at Palatine Road Palatine, IL

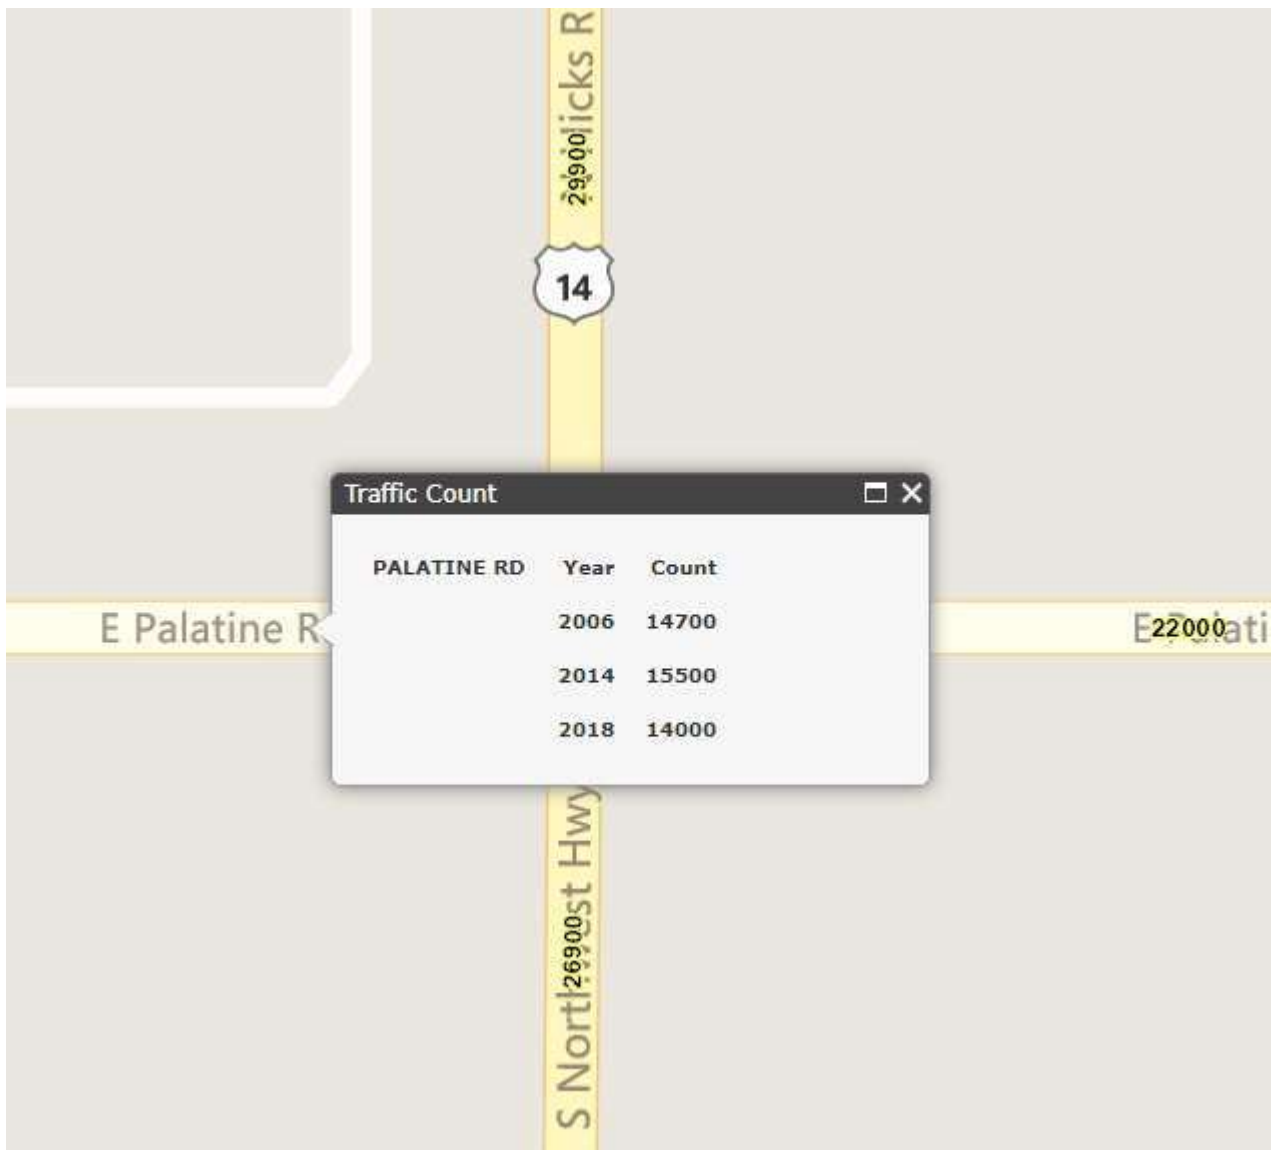
US Rte. 14 (Northwest Hwy) at Palatine Road (Eastbound)

Data was obtained from the Illinois Department of Transportation's website www.gettingaroundillinois.com.

- 14,700 (2006)
- 15,500 (2014)
- 14,000 (2018)
