US Rte. 12 (Rand) at Hicks Road Palatine, IL

US Rte. 12 (Rand) at Hicks Road, Northwest bound Approach

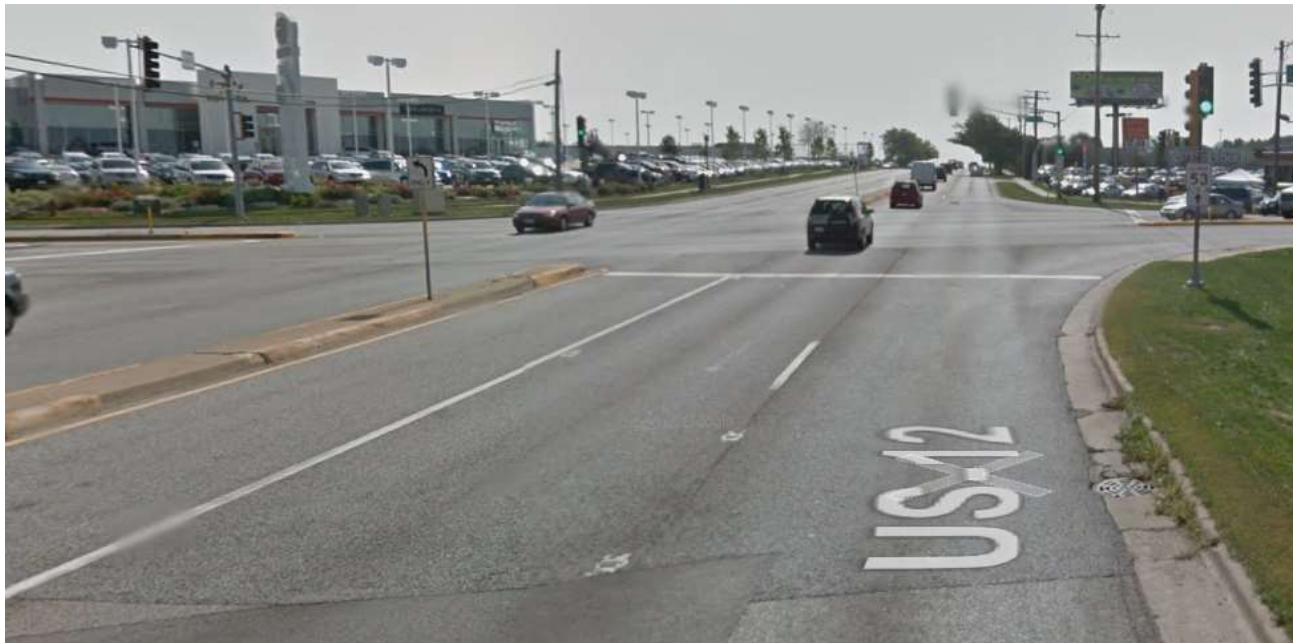
US Rte. 12 (Rand) at Hicks Road, Southeast bound Approach

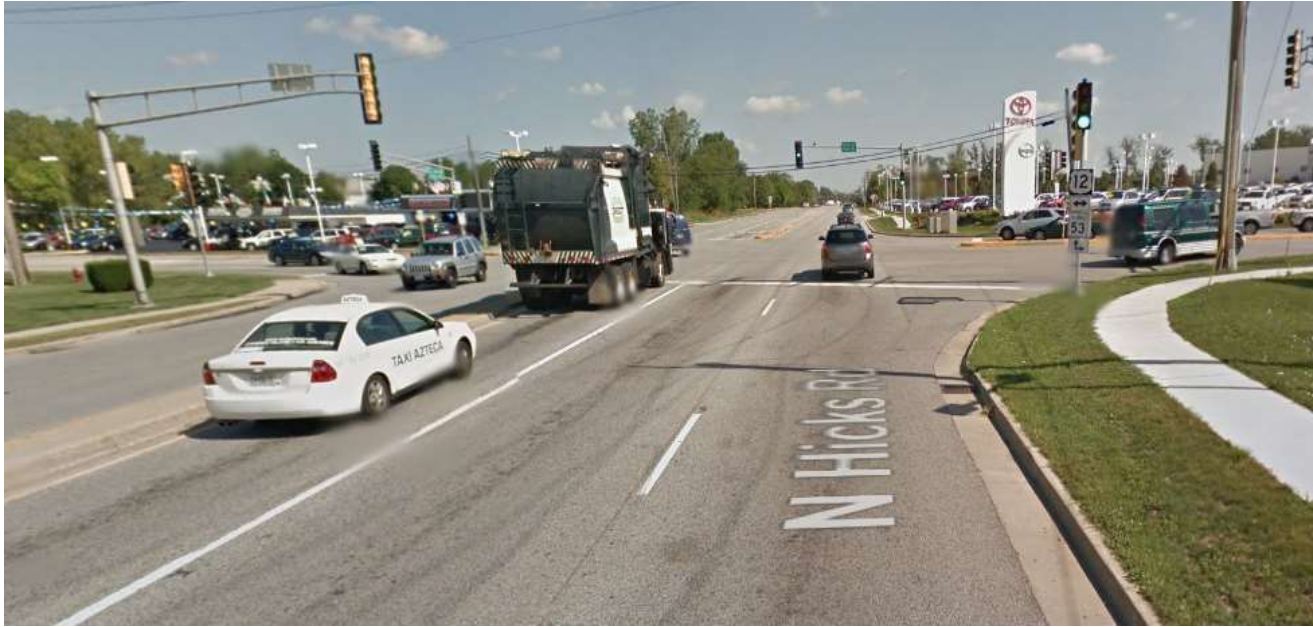
US Rte. 12 (Rand) at Hicks Road, Northeast bound Approach

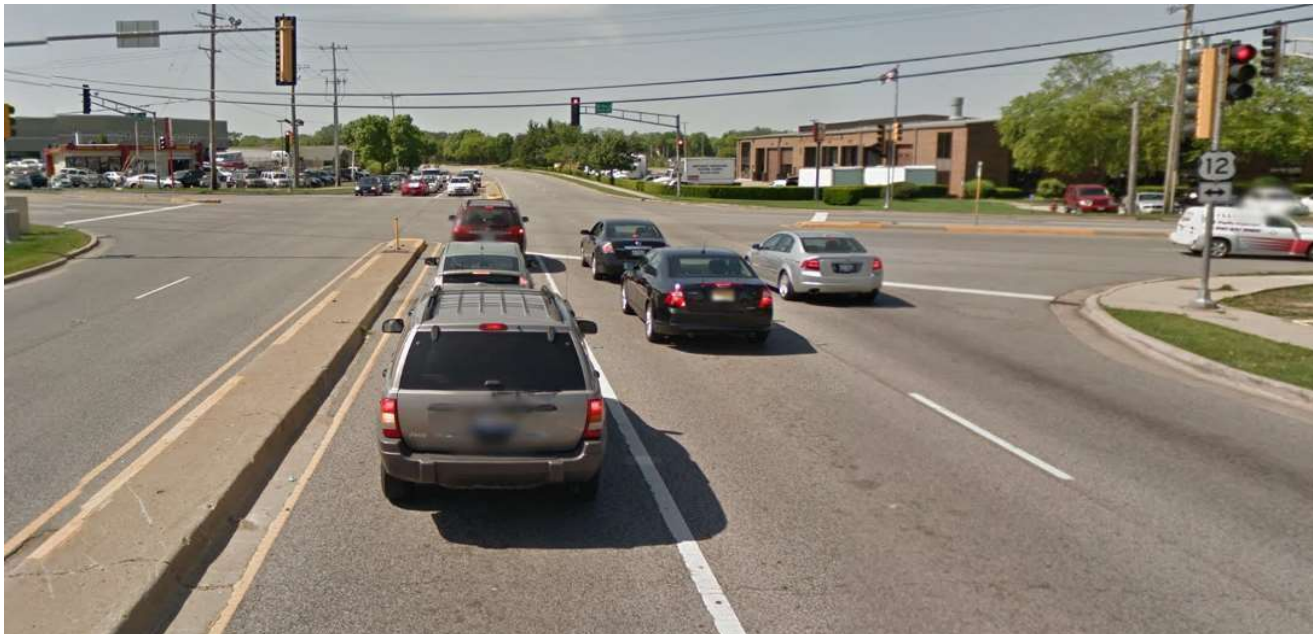
US Rte. 12 (Rand) at Hicks Road, Southwest bound Approach

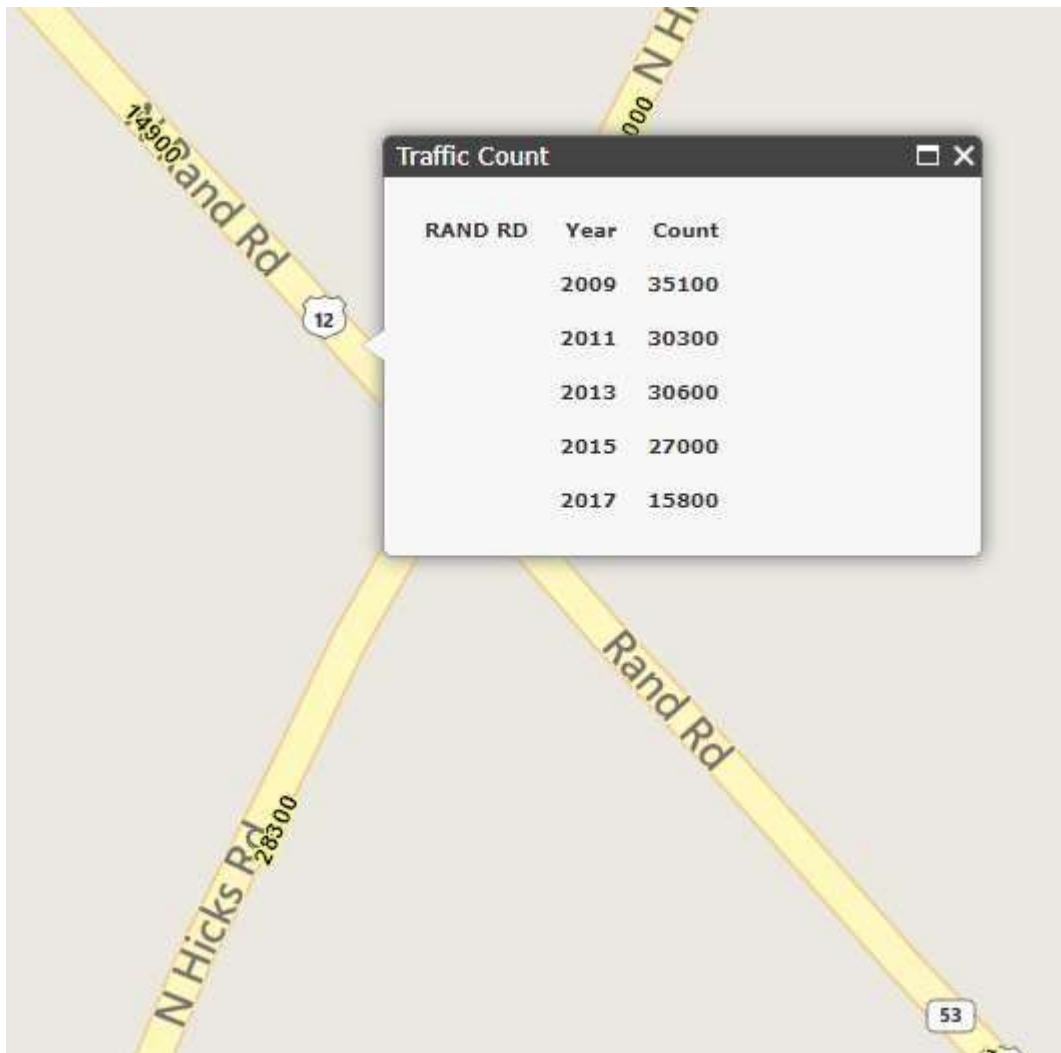
US Rte. 12 (Rand) at Hicks Road (Southeast bound)

- 35,100 (2009)
- 30,300 (2011)
- 30,600 (2013)
- 27,000 (2015)
- 15,800 (2017)

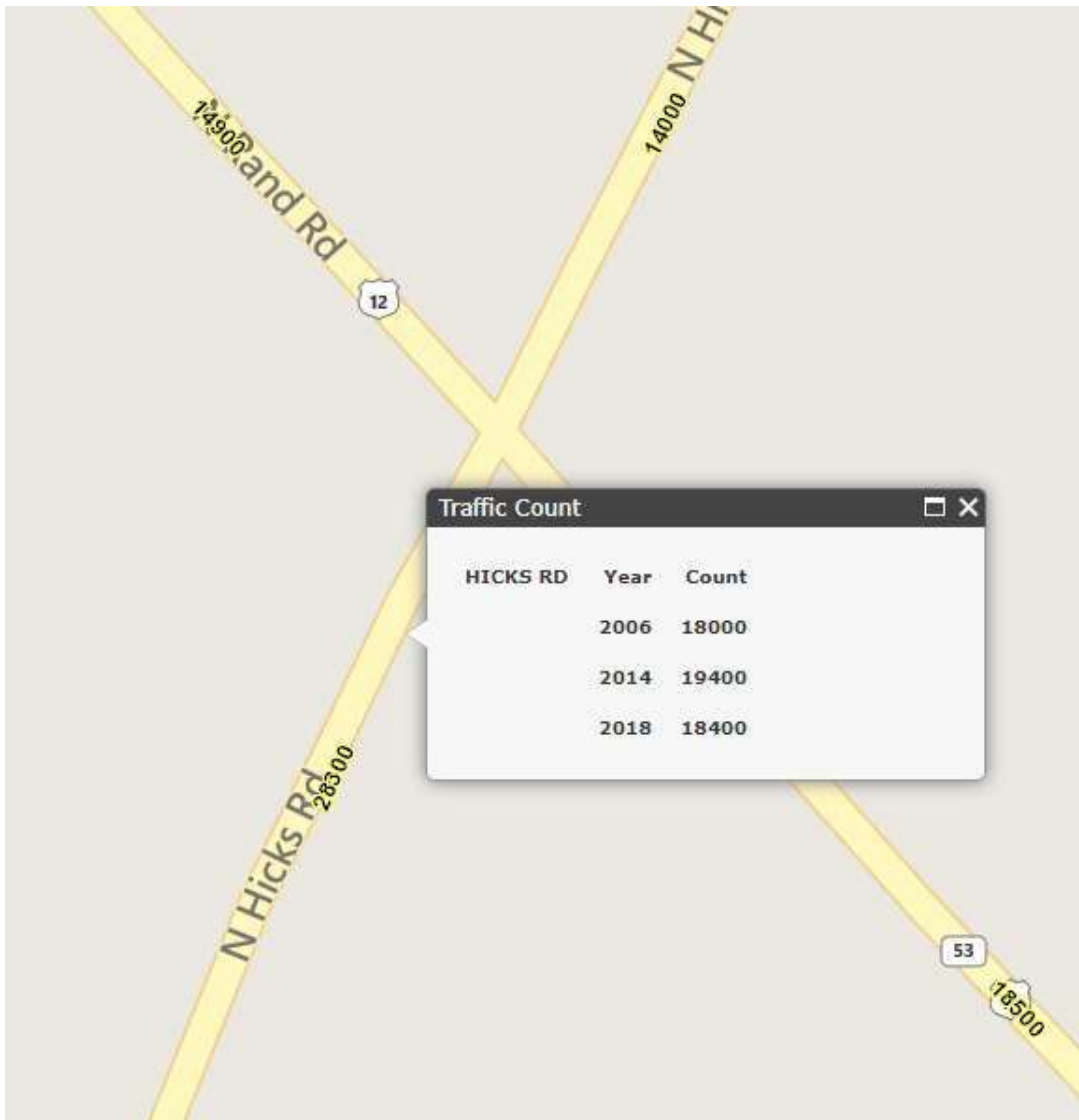
US Rte. 12 (Rand) at Hicks Road (Northeast bound)

- 18,000 (2006)
- 19,400 (2014)
- 18,400 (2018)

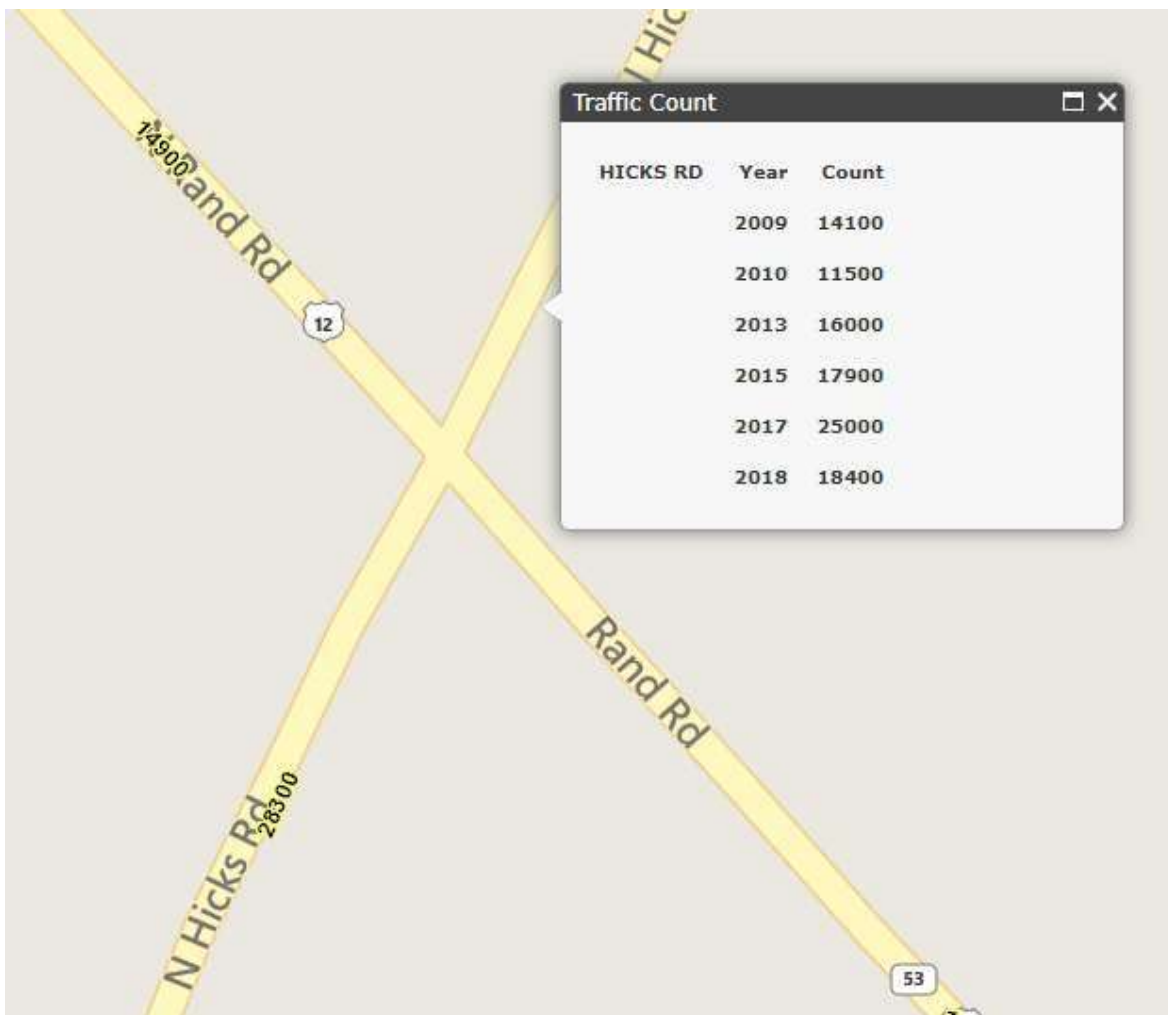
US Rte. 12 (Rand) at Hicks Road (Southwest bound)

- 14,100 (2009)
- 11,500 (2010)
- 16,000 (2013)
- 17,900 (2015)
- 25,000 (2017)
- 18,400 (2018)
